# BELZONA LINES HIGH TEMPERATURE ETHANOL VESSEL

ID: 8449

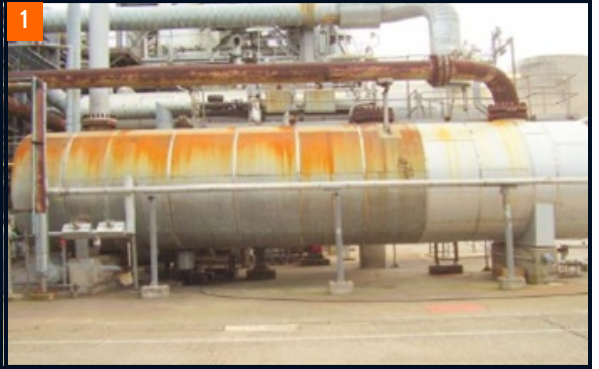
- 1 - Vessel external
- 2 - Belzona 1511 applied to areas of weld overlay
- 3 - Belzona 1593 first coat
- 4 - Belzona 1593 second coat
