# BELZONA REPAIRS LEAKING GATE VALVE

ID: 8450

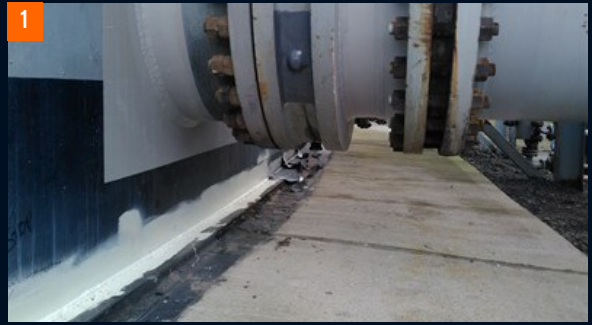
1 - Gate Valve

Hot works in the area were not possible due to the asset remaining in service. The plug was no longer effective, and the leak required sealing.

A large diameter valve had a redundant plug that was leaking fluid. A cold solution was required to seal this leak.

The area was prepared mechanically. Belzona 1212 was then applied to the surface to prevent any further fluid egress and encapsulate the plug in accordance with Belzona System Leaflet VPF-11.
