# BELZONA REPAIRS AND PROTECTS SEPARATOR OUTLET IN PAPER MILL

ID: 8466

Basalt lined outlet area of a separator in a paper mill.

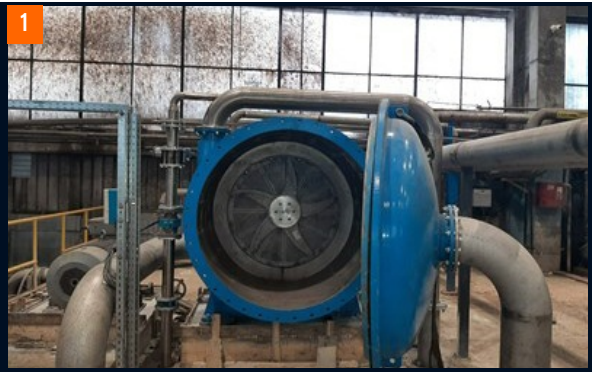
1. View of the Separator
2. Cracked outlet pipe
3. Crack repaired with Belzona 1111
4. Application completed with Belzona 1811

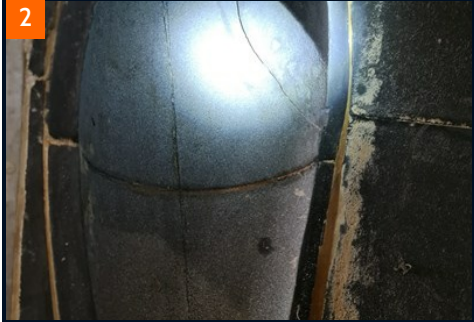
The Basalt lining was worn due to the erosive operating conditions of the separator. In the outlet pipe, a crack had formed due to the high impact loading in this area.

The cracked area has warped, leaving one side of the crack raised above the other, which in turn accelerated the abrasive wear. Traditional solutions such as welding would only fill the gap and not allow for a smooth finish to help reduce the abrasive wear. Belzona was able to reinforce the cracked area and smooth the internal section of the pipe. Belzona 1811 was chosen due to its high abrasion resistant properties and ease of application in situ. The application was completed within 2 days, keeping down time to a minimum.

The surface was prepared with mechanical power tools to roughen and clean the surface of both the Basalt and the steel. The cracked area was then repaired using Belzona 1111 to bond a reinforcement plate over the defect area, inline with Belzona System Leaflet TCC-2. Belzona 1811 was then applied to the outlet pipe and to some worn areas of the Basalt lining inline with Belzona System Leaflet SHM-11, offering additional erosion and abrasion protection.
