# WASTEWATER REPAIR AND PROTECTION WITH BELZONA

Sewage water pipelines at a waste water treatment facility.

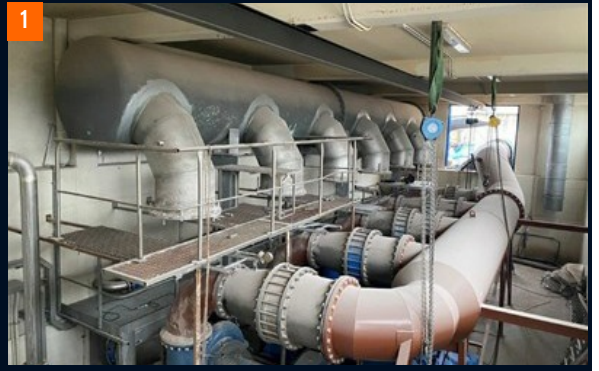
- 1 - Outside of the pipes to be repaired
- 2 - Corroded condition inside the pipe
- 3 - Surface prepared and rebuilding in progress
- 4 - Coating completed

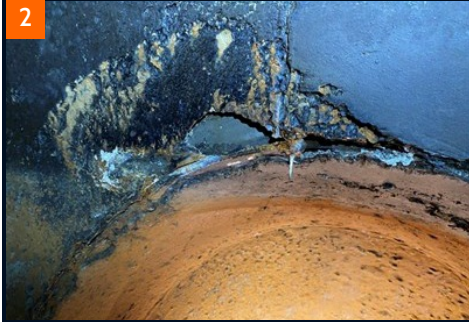
Internal corrosion of the pipelines has led to severe degradation of the substrate including heavy pitting. In some areas, the loss of wall thickness is reaching a stage where the structural integrity of the pipeline would be compromised. Action is needed to repair the existing damage and prevent further corrosion.
