# BELZONA RESTORES STRUCTURAL INTEGRITY AND STOPS LEAK.

ID: 8470

Binary cycle power plant, Central north island, New Zealand.

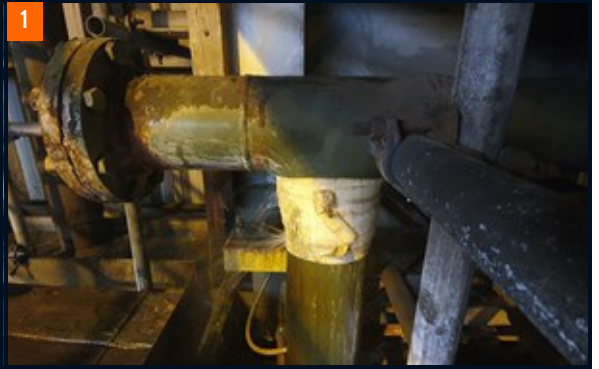
Corrosion and thinning of the pipeline had failed on most welds. There was an area on a T-junction where the line was leaking extensively. Due to the awkward positioning of the pipe, welding was not possible.

1. Badly damaged T-section of the pipe
2. Manually prepped surface
3. Application of Belzona Superwrap II
4. Final output

The application was carried out as per the Belzona System Leaflet VP11 and Belzona Superwrap II method statement provided. In order for the products to adhere successfully to the substrate, we had requested the organization to divert the water supply from the pipeline. Once this was achieved, We had to manually prep the substrate. Belzona 1161 was used to rebuild the profile and stop the leak. After consulting the IFU for 1161, Belzona 1982 was used. The Belzona SuperWrap II release film was then wrapped over the repair and the left to cure.
