# BELZONA BACKHOE BUSH HOUSING REPAIR

ID: 8472

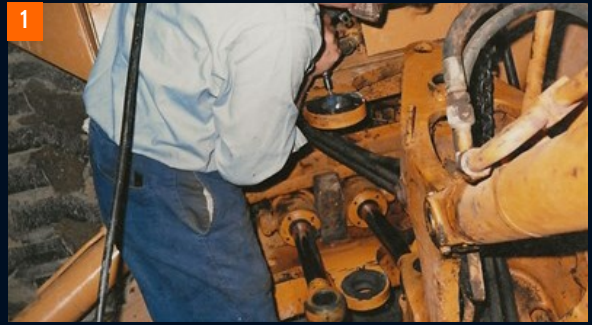
The bush housings, where the boom attaches to the machine, were worn till they were oversized that it was difficult to properly control the boom when digging. Also, it was the busy construction season and the owner needed the machine back as soon as possible. The machine shop where it was taken for repair suggested they try a procedure using Belzona 1111, which had recently been introduced to the machine shop owner.

1. Preparation of the worn housings by grinding
2. New bushings grouted in and alignment rod in place
3. The cracked boom which resulted from hitting an underpass

Application was carried out in accordance with Belzona Know-How System Leaflet MPT-07. The worn housings were degreased, ground to produce a rough profile and degreased again. Release Agent was applied to the OD of new bushings and allowed to dry. Belzona 1111 was mixed and applied to both the prepared housings and onto the new bushings, on top of the release agent. The bushings were inserted into the housings and a steel rod, exactly the size of the bushing ID, was run through both bushings to provide alignment. The repair was allowed to cure overnight. Next morning the machine was reassembled, the owner picked it up and it was digging later that day.

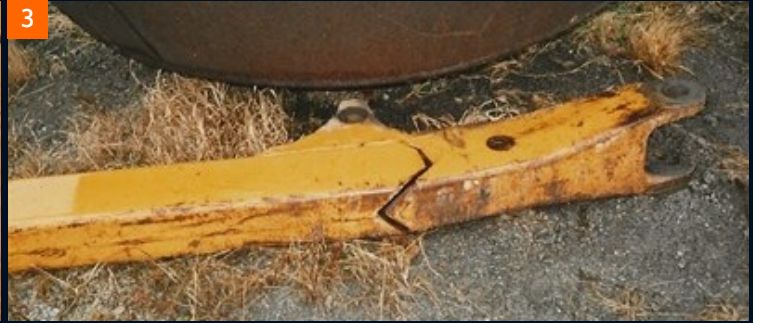
The owner was delighted that the backhoe was only out of service one day, as opposed to two or more for welding and line-boring, as this shop had done for him in the past. The cost of the Belzona repair was a fraction of the welding approach and the machine required minimal disassembly. This repair was followed for over 5 years with no problems. During that time, the boom was cracked when it hit a low underpass while the machine was being transported. The Belzona 1111 repair remained intact. (see photo #3)
