# BELZONA REPAIR AND PROTECT OFFSHORE CLOSED DRAIN TANK

ID: 8475

Internal repair and coating of offshore FPSO closed drain tank.

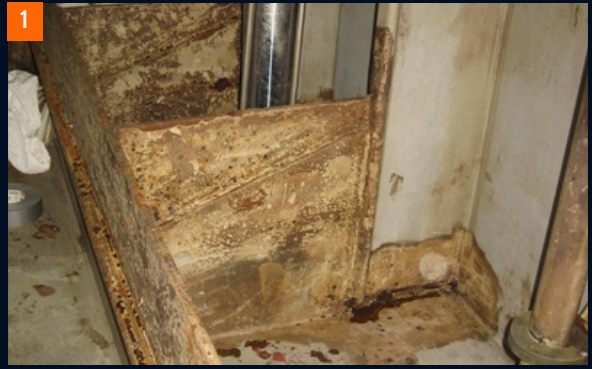
Severe pitting corrosion in bottom section of internal closed drain tank, due to coating failure. Metal loss in areas measured to 6-8mm deep.

Picture 1. Corroded tank bottom

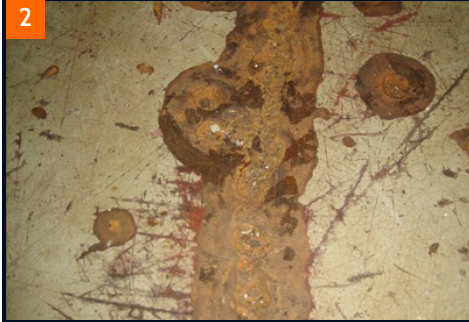
Picture 2. Severe pitting corrosion

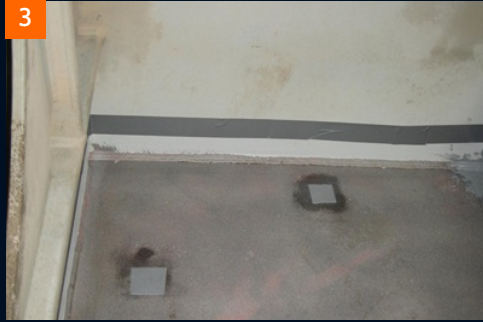
Picture 3. gritblasted surfaces and rebuilding of pits using Belzona 1111 Supermetal

Application was carried out in accordance with Belzona Know-How System Leaflet TCC-5. Following gritblasting, Belzona 1111 Supermetal was used to fill all pitted areas in the tank bottom. All tank bottom surfaces were then coated in Belzona 5811 Immersion Grade.

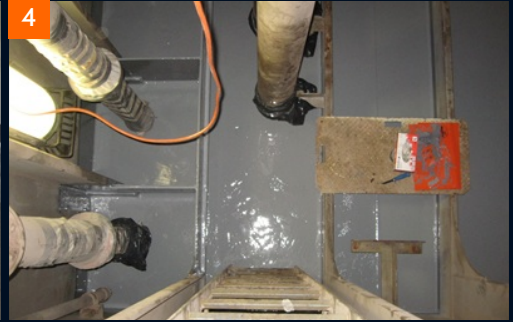
Picture 4. Tank bottom coated with belzona 5811 Immersion grade.
