# BELZONA SCRUBBER FAN COATING

ID: 8476

New Scrubber Fan being fabricated and in need of corrosion protection.

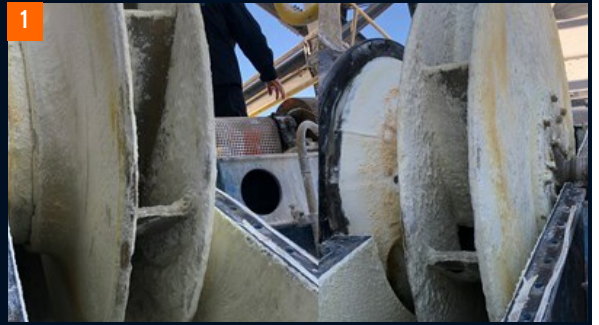
Particulates had corroded the previous scrubber fan surface. Items were building up on the steel and affected the balance.

1- Corroded previous Fan

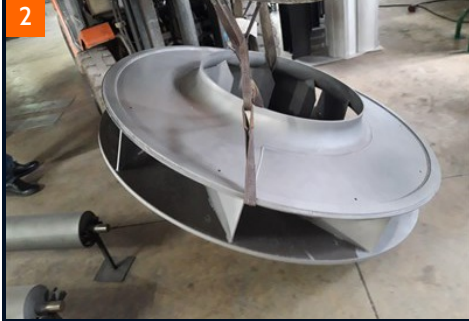
2- Surface Preparation - After grit blasting

The application was carried out in accordance with Belzona Know-How Leaflet FBC-2.

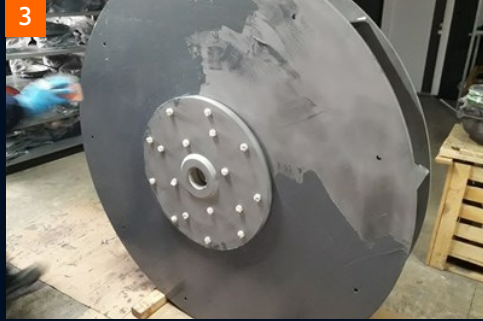
3- During the application

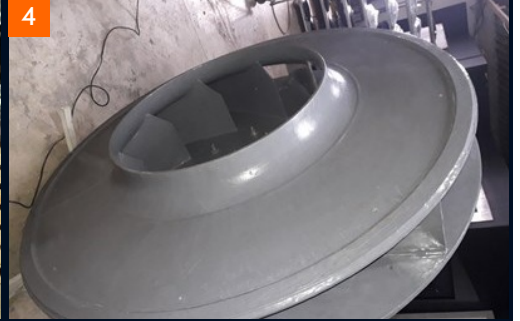
4- Completed application with Belzona 1321

Firstly, the customer thought that stainless steel faced fan production would be more expensive than carbon steel faced fan production. Due to this reason, they had a carbon steel faced fan manufactured and they coated with Belzona 1321.
