# BELZONA REPAIRS ROBOTIC ARM

ID: 8477

Broken robotic arm

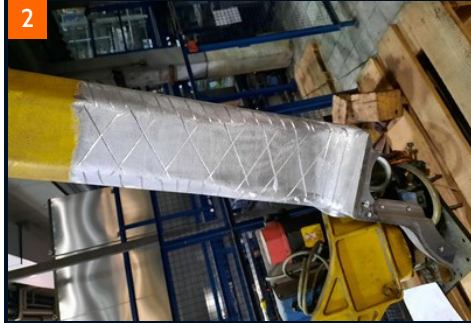
The robotic arm, that lifts and moves around large plastic beer boxes, from stack to process lines, was totally broken due to the metal wear. It had been working continuously for the last 20 years.

1. The view of the broken robotic arm
2. The view of the surface prepared by using the MBX
3. The two pieces of the arm with the wrapping of the reinforcement sheet
4. The robotic arm with the completed repair.

After proper surface preparation, the application was carried out by putting the metal plates with screws on the broken arm. Belzona 1111 was applied between the two pieces of metal right on the tear of the pieces. After bonding the two pieces of the arm, the reinforcement sheet (Belzona 9341) was wrapped around the entire damaged area, which was wet out with Belzona 1111.
