# TURBO SEPARATOR REPAIR WITH BELZONA 1818

ID: 8480

Turbo separator in Paper recycling plant

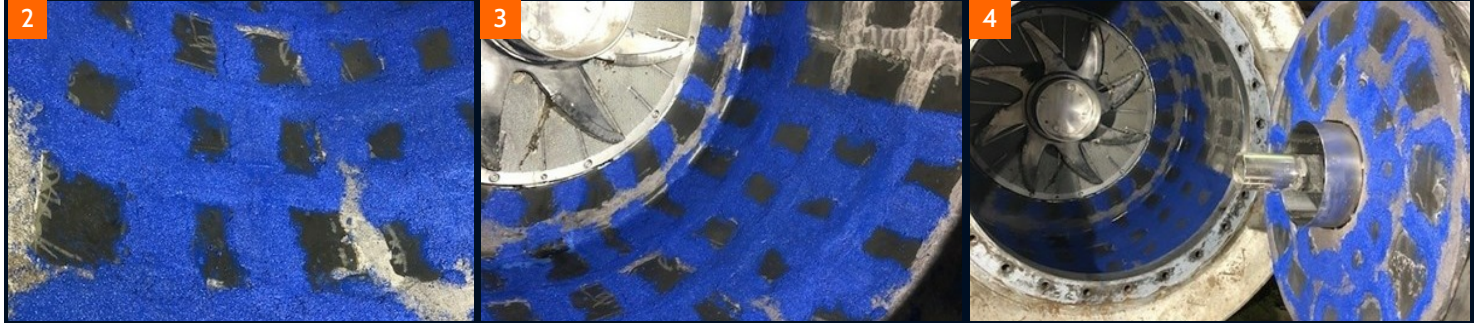
The Turbo Separator is a disc screen specially designed for course screening, primarily removing light and heavy impurities from wastepaper. The unit is lined with thick Basalt tiles and has a hard-wearing grouting compound applied over the joints between the tiles. Over the years, this grouting compound would wear away leaving the joints unprotected. This is a very abrasive environment.

1. Worn grouting system
2. Application in progress
3. Application in progress
4. Application complete

After cleaning out the pulp, the Turbo separator was dried out using rags. Surface preparation was achieved using a diamond blade on an angle grinder to create a "key" for Belzona 1818.

Belzona 1818 was mixed and applied with ease, including overhead areas.
