# BIG VACUUM OVEN REPAIR WITH BELZONA 1593

ID: 8481

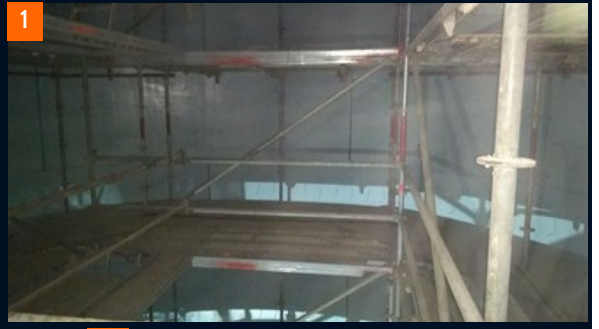
1. It was necessary to erect up scaffolding.
2. Steel prickles were coated too.
3. 2nd coat of Belzona 1593 applied.
4. Oven ready to use.

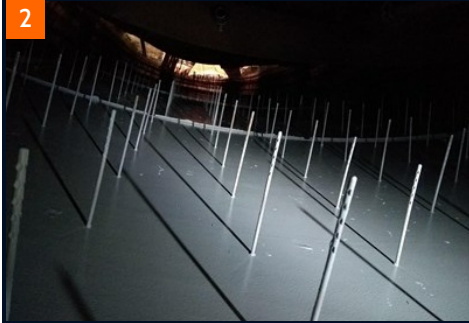
The problem was: steel prickles inside which keep the oven insulation are degraded from acids throughout the life. Oven needed the protection against acids in high temperature.
