# REPAIRING AND COATING OF THE CONCRETE SULPHUR TANK

ID: 8483

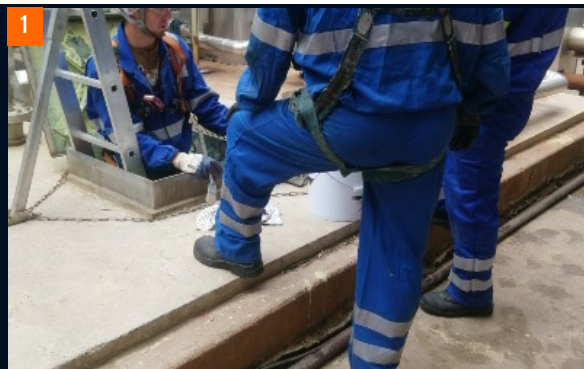
The concrete underground tank for liquid Sulphur was damaged. The longer wall of the tank crashed down. 100 % liquid Sulphur in this process can have a temperature up to 150°C and customer needed quick and quality repair.

1. Customer needed to repair concrete underground tank
2. After the Belzona 4981 application
3. Belzona 4181 application
4. Sulphur concrete tank ready to use

The application was carried out in accordance with Belzona System Leaflets TCC-9 and TCC-15. Damaged and loose concrete was removed. Then we used the blasting process. We made sure the surface of the concrete is clean/dry/free of any loose contaminants and then we used to condition the surface with your 4981. The eroded vertical surface of the tank was rebuilt with Belzona 4181. In the end Belzona 1392 has been applied.
