# BELZONA OFFERS CHEMICAL RESISTANCE AT DRINKS MANUFACTURING PLANT

ID: 8485

One of the world's largest producers, distributors and sellers of non-alcoholic beverages need a solution for a drain on a CIP installation.

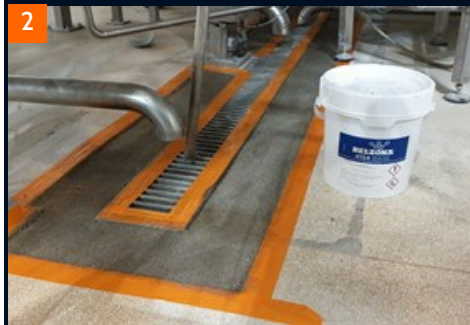
The customer had previously performed two repair attempts using traditional repair methods. During the previous repair, the sealing was covered with a chemically resistant sheet. This solution was verified by high temperature and aggressive medium. Frequent and intensive washing during the production process caused the sheet to detach, which resulted in increased leaks between the concrete surface and the metal outflow, which resulted in further degradation of the substrate under the sheet and along the drain line. Repeatedly performed traditional repair methods assisted with the use of sheet metal covers have proved ineffective.

1. Leaks on existing drain area.
2. Application of 4981 on the roughened surface.
3. Large area of drains to be protected.
4. Completed Application

Applied using Belzona Know How System Leaflet FPA-3 Incision and forging of the degraded substrate around the drain. Ensuring the surface was clean, rough and dry. Application of Belzona 4981 activator to the prepared substrate. Rebuild larger cavities with a mixture of quartz sand and Belzona 4154 resin. Application of a chemical-resistant lining with Belzona 4181 composite, approx. 6 mm thick, on the rebuilt surface.
