# BELZONA PROTECTS WASTEWATER EXPANSION BELLOWS.

ID: 8488

Rubber expansion bellows on water circulation pipes at a wastewater treatment plant.

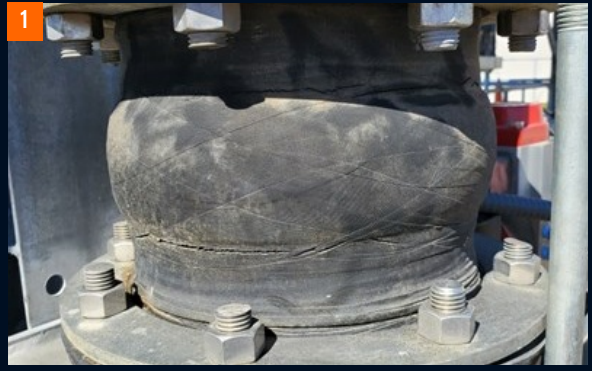
These rubber wastewater expansion bellows were being weathered by UV and exposure resulting in cracking.

1. Original condition.
2. Belzona 2911 applied.
3. Belzona 2221 and 9341 applied, application complete.
