# BELZONA 1212 FOR EMERGENCY PUMP REPAIR

ID: 8489

Wastewater lift station pump

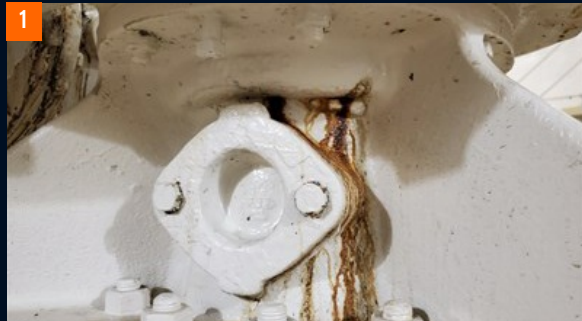
A faulty section of weld on the lower side of the pump was leaking raw sewage.

1. Original condition of the pump.
2. Paint removed and ready for the 1212.
3. First application of 1212 with a small drop of water on the left side.
4. Second application of 1212 and leak sealed.
