# BELZONA COATED CHILLERS 10 YEARS ON

2500 ton Chiller units used for the Olympic Installations

Olympic Stadium: Montréal, Canada

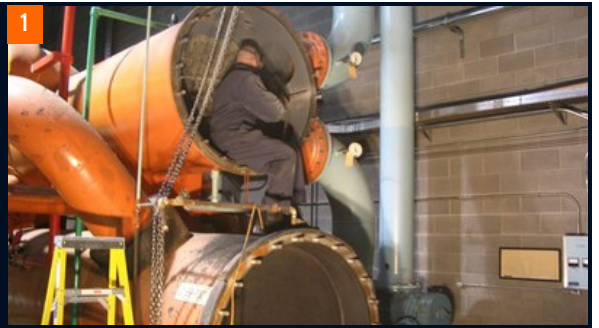
1. The chiller units
2. The covers required minor touch-up
3. The separator bar after 10 years
4. The separator good for another 10 years
