# DAMAGED LOADING BAY STAYS STRONG WITH BELZONA

ID: 8495

Concrete loading area for gas cylinders.

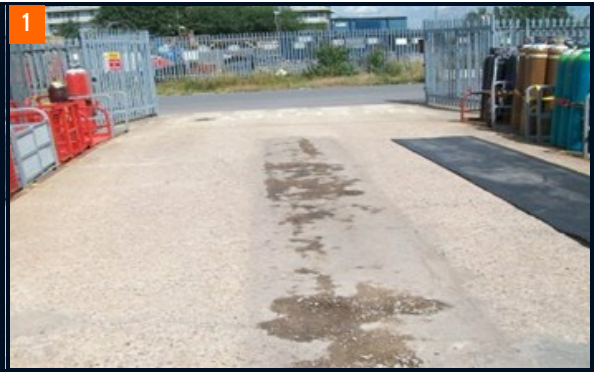
The surface of the concrete ramp had become damaged due to impact from the gas cylinders when being loaded and unloaded, even though they are dropped onto a rubber mat. The uneven surface was making it increasingly difficult for the tall narrow cylinders to stand up safely.

1. 8.5m x 5m concrete loading area damaged by impact
2. Extent of the damage
3. Repaired with 6mm of Belzona 4131
4. Application revisited in 2021 after 9 years in service

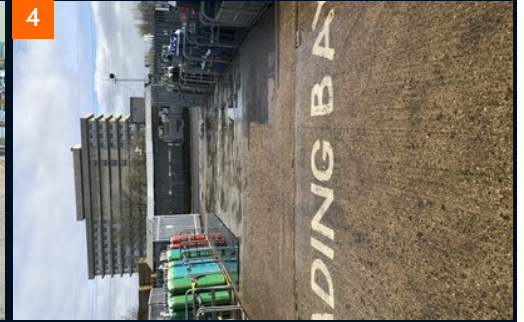
This is a common problem on many gas distribution sites across the UK. Belzona was selected firstly for its ability to protect against impact and abrasion. Secondly for being impermeable and resistant to frost damage. After nine years of constant loading and unloading of gas cylinders the loading bay has been revisited in May 2021 and was found to be in excellent condition. The client is very impressed with the Belzona solution provided and has since implemented a variety other successful Belzona applications across their UK sites.
