# BELZONA PROTECTS A HEAT EXCHANGER IN A CHP PLANT

ID: 8496

Protection of a heat exchanger at the CHP plant in Southern Poland.

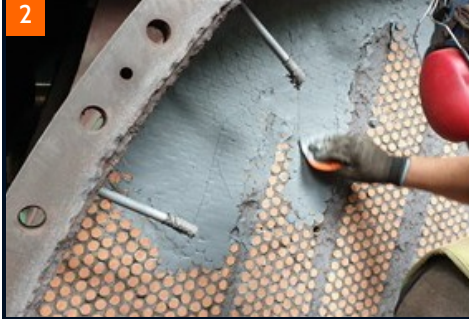
Image 2: Application of Belzona 1121

Corking of tube sheets. Abrasive blasting of the perforated plates, chambers and condenser bottom. Cutting off the protruding parts of the plugs. Thorough dedusting of the entire surface to be repaired. Filling the spaces between the tubes and deep pits with Belzona 1121 followed by Belzona 5811 application in a two layer system in accordance with Belzona System Leaflet HEX-1

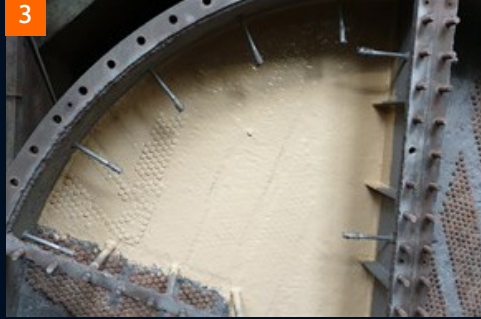
Image 3: Application of Belzona 5811
