# BELZONA ABRASION PROTECTION OF VACUUM MACHINE PARTS

ID: 8497

Housing, pipes and cone fittings from truck vacuum machine

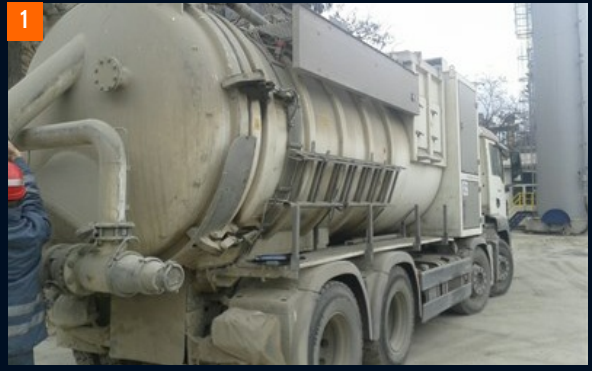
High wear of the housing, pipes and cone fittings, caused by aggressive abrasion of various materials in the production process

1. Appearance of the vacuum material collection machine
2. Preparation of the inner surfaces of the housing
3. Belzona 1812 applied on the internal surface
4. Belzona 1818 applied on the internal surface.

This work for protection takes place routinely in the local cement plant per year. New pipes last one year before being damaged. This is why Belzona is used to protect the new parts of this machine. In this case, due to severe damage to the housing, pipes and cone fittings, new pieces of steel sheets were welded by another specialized company and then the parts were protected internally. Belzona 1111, Belzona 1812 and Belzona 1818 were used. The time given for repair, protection and solidifying of the materials was very short and that is why Belzona 1818 was applied to the last part late in the evening in order to mount the parts faster on the truck and to continue working process.
