# BACKUP GENERATOR - DIESEL TANK RESTORATION WITH BELZONA

ID: 8498

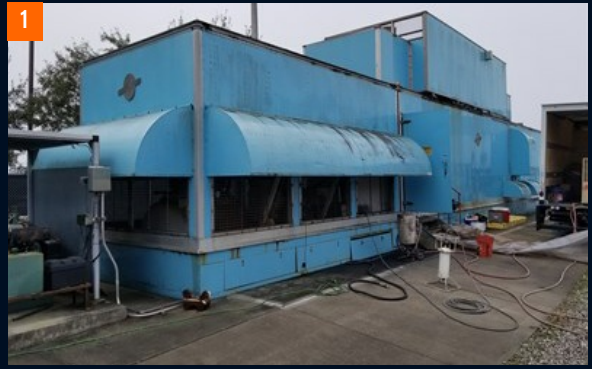
- 1- Generator
- 2- Section of Corrosion
- 3- Belzona 4911 & 4131 being applied
- 4- final coat of Belzona 5811

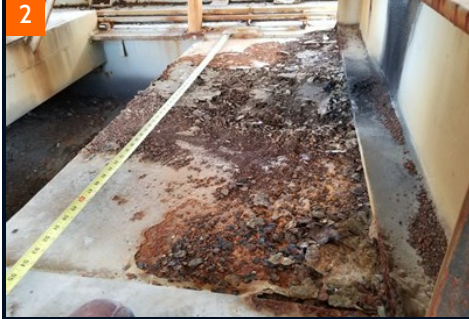
Severe corrosion on top of the tank leading to pinholes.

Clean Top of the Steel Tank. Needle Gun used to remove Heavy Scale from Years of Corrosion. Surface SpongeBlasted to a SSPC-SP10 Near White Condition. If the surface preparation perforated the metal, the repair was Cold Bonded with a plate repair using Belzona 1121. One Coat of Belzona 4911 Conditioner. Install Belzona 4131 to create a slope for the water to Evacuate from the middle on both sides of the tank. Top Coat with Belzona 5811
