# HOSPITAL - AIR HANDLER FAN WHEEL SHAFT REPAIR WITH BELZONA

ID: 8499

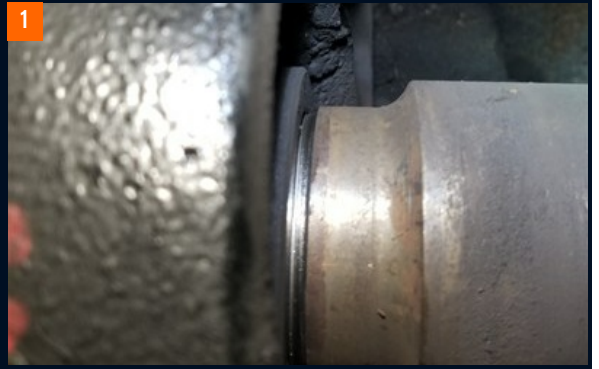
Air handler pillow bearing ceased and galled a 1/8" groove into the air handler fan wheel shaft.

Picture 1 - Shaft damage

3D Printed Former was commissioned through Belzona Inc. to the exact tolerances of shaft dimensions. The damaged area on the shaft was undercut and prepared with grinder and file to create ample anchorage point for Belzona 1111. Release agent added to the former surface to aid removal post cure. Material and Former put in place and allowed to follow the initial cure process. Post-cure heating was performed to accelerate the curing process to bring the air handler online as quickly as possible. The former was removed and the material refined and brought into exact tolerance with emery cloth. Post cure heating to 140°F was completed after 4 hours and the air handler was assembled and put back into service.

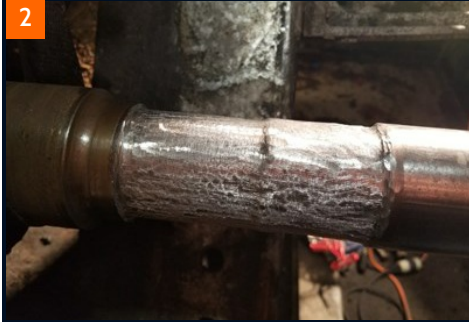
Picture 2 - Shaft surface prepared

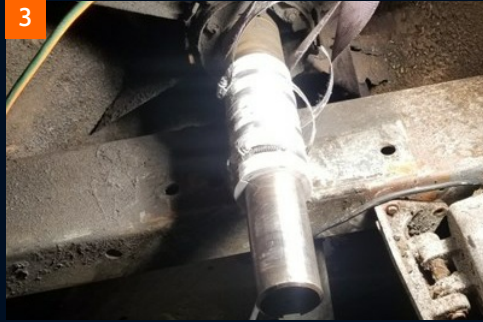
Picture 3 - 3D former in place

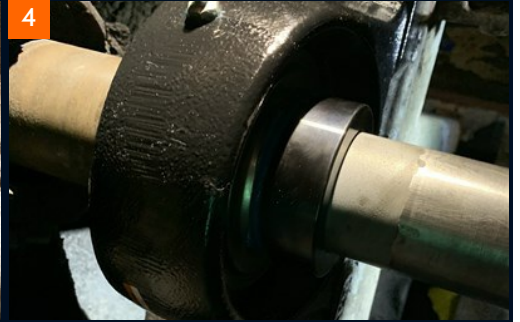
Picture 4 - New bearing in place
