# BELZONA REFURBISHMENT OF MOORING WINCH BRAKE DRUM

ID: 85

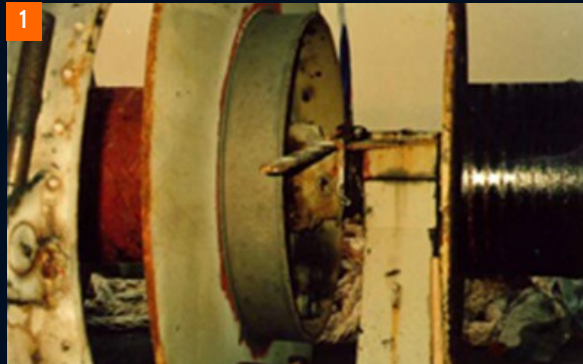
Erosion/corrosion

Mooring winch brake drum with a diameter of 1150mm and width of 150mm.

1. Surface grit-blasted to SA2.5
2. Guide plate in place
3. Rebuilt with Belzona 1311
