# A SMALL HOLE CAN CAUSE BIG PROBLEMS, BUT BELZONA PROVIDED THE SOLUTION

ID: 8505

A hole in a weld developed due to Corrosion Under Insulation on nozzle of an Acrylic Acetate vessel. The plant needed a solution to get them 3-4 months of service until a turnaround without losing any production time.

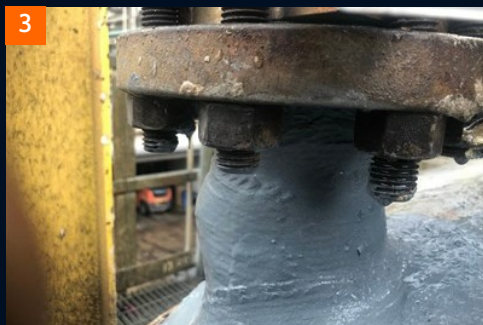
The hole was below the fill line in the carbon steel vessel that was operating at 7-10 PSI with a designed temperature range between 120-140C. The customer needed an immediate solution on a Saturday and within 7 hours of the call a Belzona crew was onsite to repair the nozzle. Plant maintenance had placed a hose clamp with rubber patch over the hole and this was included as a defect in the final repair design.

- 1 - Vessel location
- 2 - Through wall on Weld
- 3 - Finished Job #1
- 4 - Finished Job #2

Application was carried out in accordance with Belzona Know-How System Leaflet VPF-11. The repair area was prepared using spark free vapor blast and tools to clean and roughen the substrate to a near white SSPC SP10 finish. The repair was done in-situ while the vessel was still in operation. Belzona 1511 was used to build up around the hose clamp to achieve a smooth surface for final repair. Belzona 1392 with a reinforcing cloth was then used to wrap the entire nozzle and onto the vessel body with a final coat of 1392 over the entire repair.
