# BELZONA GUIDES ITS CLIENTS INTO REBUILDING & PROTECTING AN ASSEMBLY LINE BUFFER CHAIN GUIDE

ID: 8506

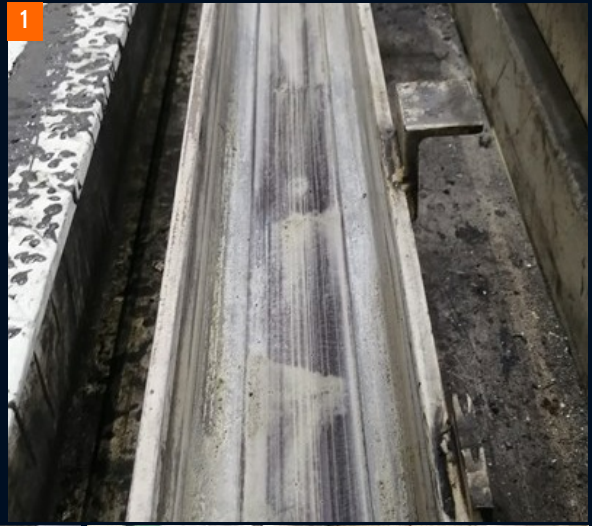
The conveyor chain had worn the channel that guides it by 6-8mm over a period of 10 years.

- 1). Problem Area
- 2). Specific Grit-blasting Dust Extraction Tool
- 3). Application of Belzona 1311
- 4). Final Application
