# GENERATOR-SIDE COVER WEAR TACKLED WITH BELZONA

ID: 8517

A steel cover at a hydropower station, which sits on the generator side of the turbine.

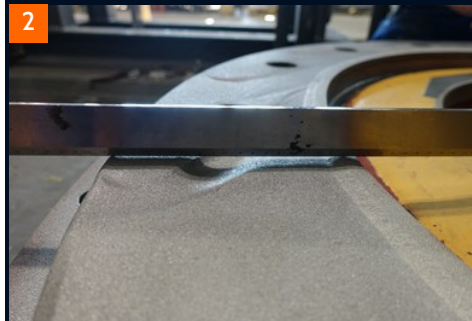
The flat surface of the cover, where the turbine guide vanes are mounted, was very heavily worn. Additionally, the outer diameter of the cover had worn, becoming very uneven and losing up to 5cm of thickness.

1. Damaged edge after blasting
2. Damaged cover face after blasting
3. Edge repaired with Belzona 1331
4. Application completed and machined to fit

The application was carried out in accordance with a modified version of Belzona Know-How System Leaflet VPF-1. The surface was prepared by grit blasting to a near white metal finish and a surface profile of 90 microns. The outer diameter of the cover was rebuilt using Belzona 1311 to create an even and concentric finish. The face of the cover was then coated with Belzona 1331 up to a thickness of 3mm. Finally, both the Belzona 1311 and Belzona 1331 were inspected, touch ups were applied to remove small air pockets, and the surface was machined to the required dimensions and finish.
