# HEAT EXCHANGER EMERGENCY REPAIR WITH BELZONA SUPERWRAP II

ID: 8519

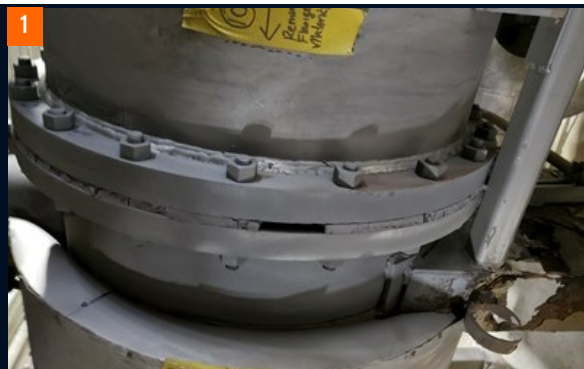
1. Grit Blasted Flange
2. 1511 HT Packed into flange and encapsulated entire circumference.
3. Heat Exchanger Flange wrapped with Superwrap II and consolidation film.
4. Final Product after 48 hour cure.

Grit Blasted Flange, the flange was packed in with Belzona 1511 applied over entire repair area, filling any voids. Applied Belzona 1983 resin to the surface and then started the wrap with Belzona Superwrap II.
