# BELZONA ELASTOMER VS SAND & WATER ABRASION

ID: 852

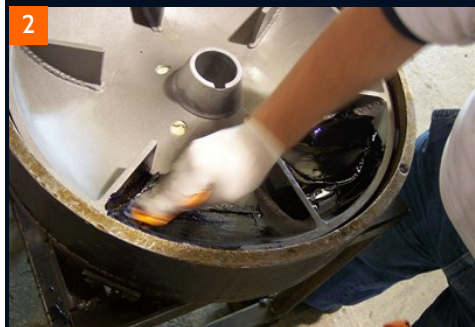
Pumping HP Sand/water slurry down a well includes a Slinger Disc which is lined with a wear material to counter the abrasion.

1. Typical wear from Oilwell service caused by sand/water at high pressure
2. New prepared slinger being wetted out with Belzona 2131
3. Mold fitted and filled, waiting cure
4. Final step - spin balancing
