# BELZONA TANK BASE SEALING SYSTEM APPLIED TO NITROGEN TANK

ID: 8529

Elevated nitrogen storage tank

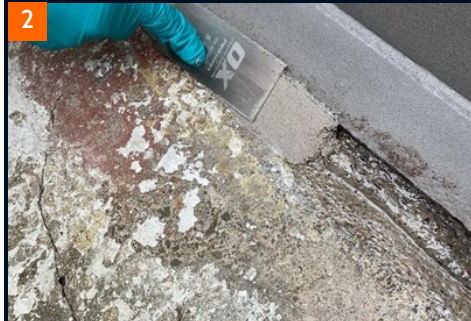
The tank had developed a void between its annular ring and plinth substrate. The asset owner had concerns that if the void had been left to deteriorate, adverse weather conditions and moisture/condensation would accumulate and track under the base of the tank. This would inevitably lead to corrosion of the tank base, leakage or even a tank failure.

1. 15m diameter tank to be repaired
2. Belzona 4131 being applied
3. Tank base sealing system in progress
4. Completed application

Once the substrate has been prepared to a standard of minimum surface profile of 75µm and a surface cleanliness of SA 2½, Belzona applicators rebuilt the damaged areas under the annular ring using Belzona 4131 to a 45° fillet which will encourage water flow away from the tank. Once complete the Belzona Tank Base Sealing system was applied in accordance with Know-How system leaflet GSS-03 using Belzona 3131 at a 500mm wide band around the complete circumference.
