# BELZONA 3121 (MR7) SEALS AGAINST WATER INGRESS ON FOOD MIXERS

ID: 8531

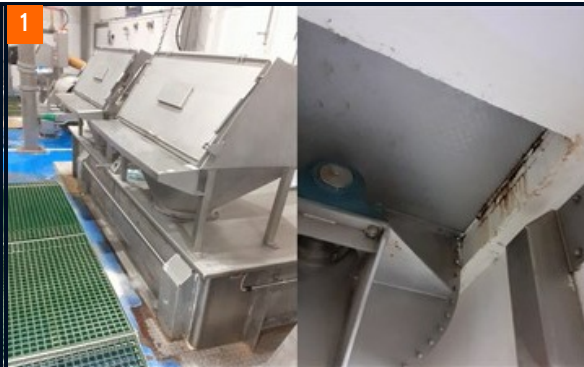
Attempts at an effective seal that could be broken and resealed again had been unsuccessful. During washdown water would sometimes leak on to the floor below and spoil the final product. The existing seal would be periodically replaced and this procedure took many hours to complete as the seal had to be fully removed and replaced. The time taken to replace the seal was problematic for the client as the mixers were run regularly and had very little idle time.

Picture 1: Mixer with old seal around the base.

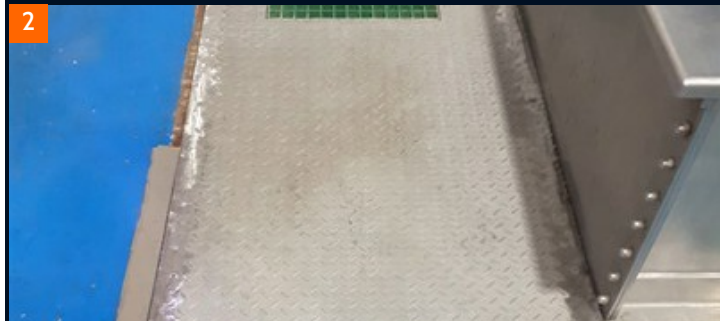
Picture 2: Underside of the mixer showing water ingress from above.

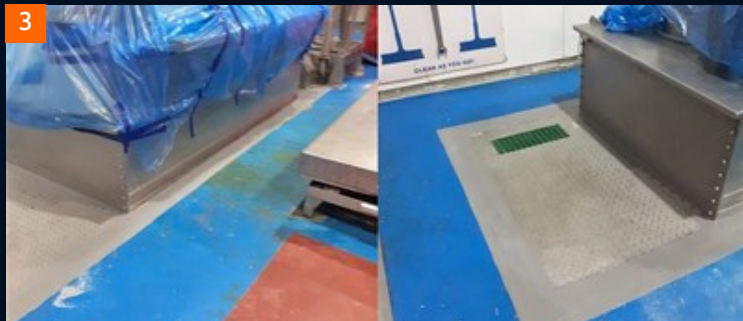
Picture 3: New seal, using Belzona 3121.

Belzona 4911 Conditioner & 4131 Magma Screed was used to bring the floor flush to the edge of the floor plates, to remove the "leading edge" that would take the brunt of the damage when pallets were placed next to the mixer. Belzona 3121 (MR7) was used to make a sealing membrane around the mixer after grinding off the checker pattern around the edges of the side plates

The existing sealing system failed regularly and required many hours of work by a team of 4 to 6 people to replace. The Belzona solution was installed over the existing seal, which saved many hours of work. While the New seal is more vulnerable to damage, as it is exposed, it can be easily and quickly be patch repaired, unlike the old seal. Also the seal around the side plates can easily be cut away with a knife to allow removal for maintenance and easily re-patched.
