# ASH SILO REPAIRED WITH BELZONA 1818

ID: 8535

The Power Station is a 750 megawatt coal fired power station.

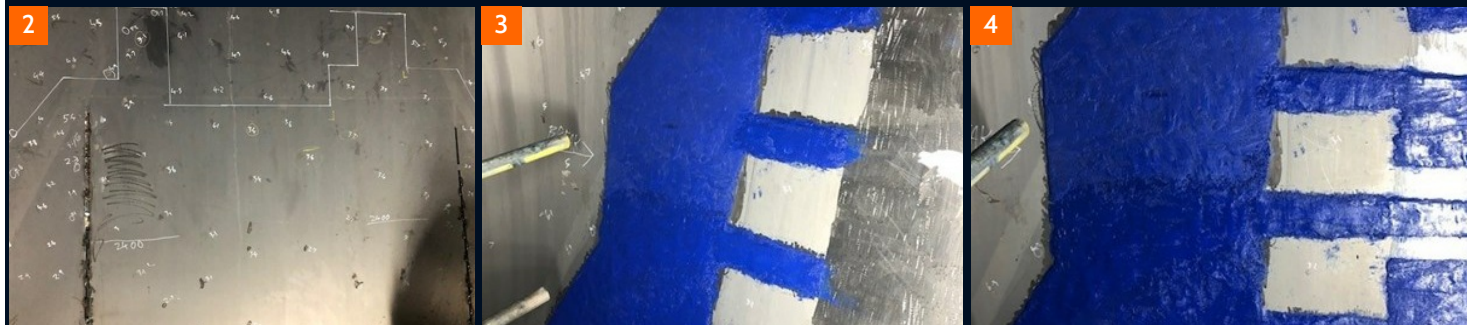
They have been experiencing rapid wear in the bottom part and particularly the Northern wall of the Bottom Ash Silo. The silo is made of 3CR12 grade stainless steel at 8.0mm thick. The wear rate is 0.25mm of wall thickness loss per month. The customer needed a quick solution to protect what metal they had left.

There were areas in the Silo walls that had worn down from 8.0mm to 3.8mm of remaining wall thickness. Rezitech were called to offer a quick solution to reduce the metal loss and protect the remaining substrate. 20 X 1 kg kits of Belzona 1818 were applied.

Picture 1: External view of the damaged Silo

Picture 2: Internal view of the damaged Silo

The product had to be surface tolerant as there was no time to get abrasive blasting organized and staged three stories up at short notice. Also, the product had to be fast curing as they needed to get back on line as quickly as possible, and of course had to be abrasion resistant. Just the job that Belzona 1818 was designed for.

Picture 3: Belzona is applying

Picture 4: Application complete
