# BELZONA 1331 REBUILDS TURBINE COVER IN THE HYDRO POWER INDUSTRY

ID: 8543

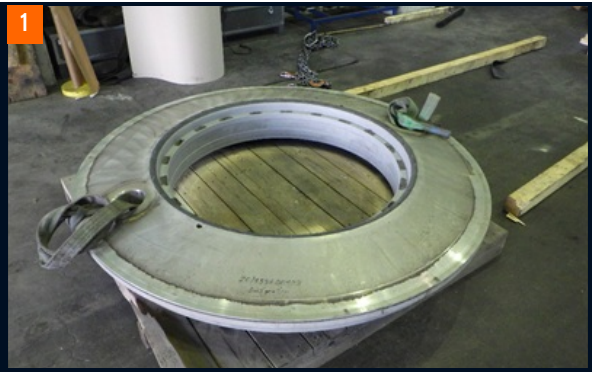
The turbine cover became oval due to welding work on the outer circumference. The fits on the inside diameter also warped. Since these surfaces already had their finished diameter, they should be built up with Belzona and then machined to the finished size.

Image 1: Turbine Cover

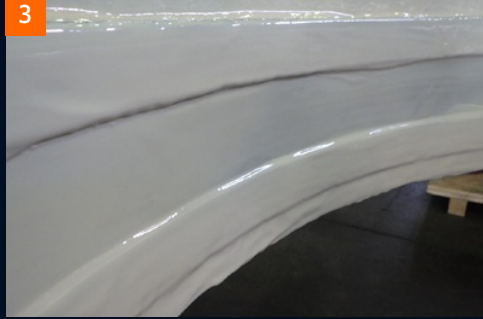
Image 3: The lid after applying the first coat of Belzona 1331

Blasted to 110 µm roughness according to Testex with blasting agent Sintox 0.2-1.4 and corundum F14 (mixed 2: 1) Cleaned and degreased surfaces Build up the surfaces with the first layer of Belzona 1331 - target layer thickness 1000 µm Build up the mating surfaces with a second layer of Belzona 1331 after approx. 3 hours - target layer thickness 1000 µm Build up the mating surfaces with a third layer of Belzona 1331 after approx. 3 hours - target layer thickness 1000 µm in accordance with Belzona System Leaflet VPF\_13
