# HYDRO POWER KAPLAN TURBINE CASE COATED WITH BELZONA

ID: 8544

## PROBLEM

The impeller shell of the Kaplan turbine at a Hydro power plant was badly damaged by cavitation and wear over several decades.

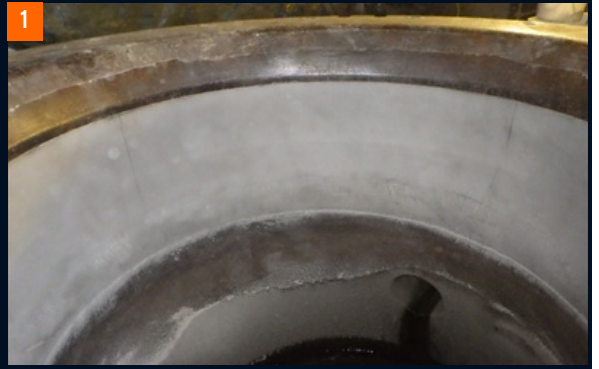
Image 1: The turbine casing after sandblasting.

Blasted to 90µm roughness according to Testex with abrasive Asilikos 0.2-1.4 (carried out by Bauschutz) Residual moisture burned out of the casting Flaws slightly raised and rebuilt with Belzona 1311 - curing: 18 hours at 15 ° C Reconstructed areas ground to the target contour Swept jacket - Belzona 1311 spots were slightly roughened and bare steel surfaces were derusted Coating of the jacket with two layers of Belzona 1321 - the first layer was completely covered within 2 hours - total target layer thickness: 600 µm Applications carried out in line with Belzona system leaflet CEP-5

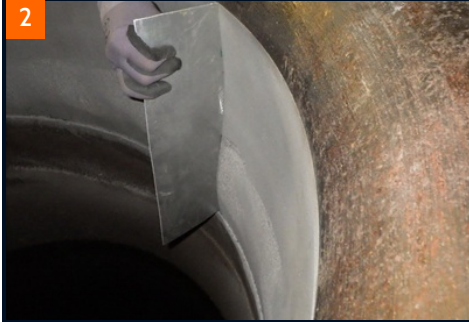
Image 2: Before the reconstruction, a template of the target shape was made.

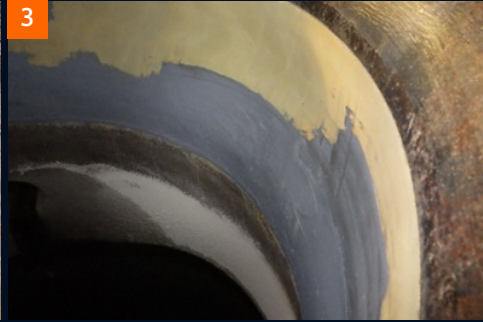
Image 3: Belzona 1311 applied to rebuild the profile.

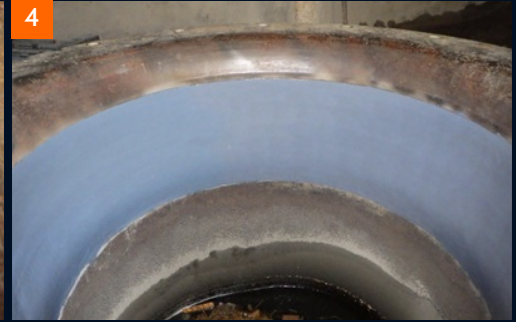
Image 4: Complete with a top layer of Belzona 1321
