# BELZONA IN THE CEMENT INDUSTRY

ID: 8545

Ball Mill 4000mm diameter in Germany.

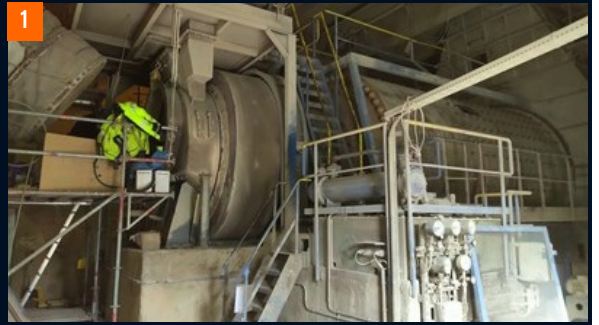
1: Ball mill in a cement plant (diameter 4000mm)

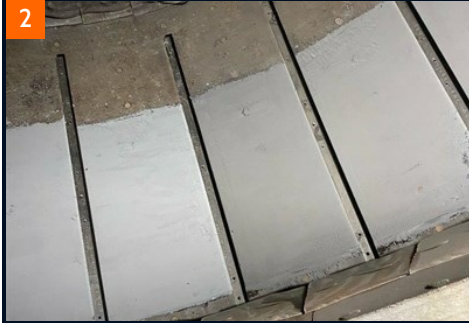
2: Belzona 4111 and steel base for the right height (for Belzona 4111 and 1812 with two different templates)

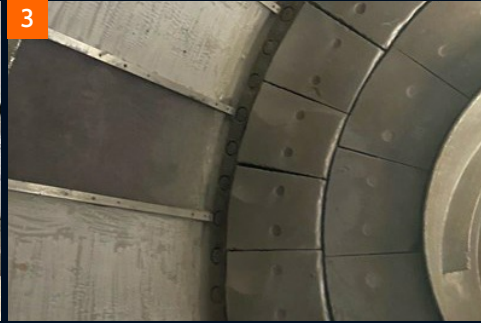
3: Every second area complete rebuild with Belzona 1812 (4mm)

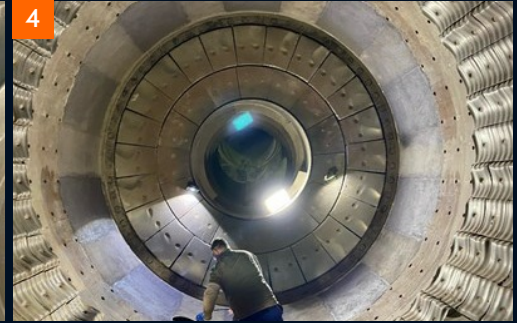
4: After removing the steel base 1812 applied in the rest of the area
