# BELZONA PROTECTS A CONCRETE FLOOR FROM FUTURE OIL INGRESS

ID: 8546

Workshop floor renovation.

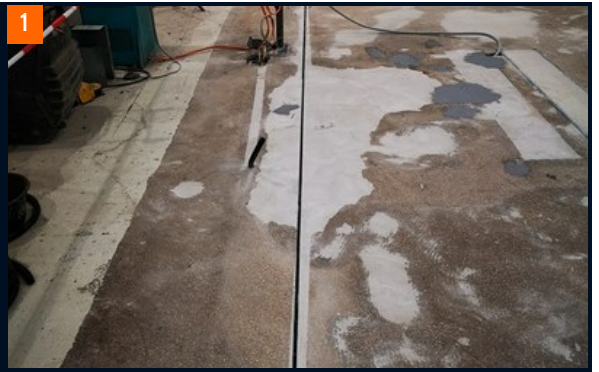
The concrete (70m<sup>2</sup>) was softened and damaged due various oils being spilled over the area.

1. Removal and installation of the defective floor by scarifier/grinder.
2. Cutting expansion joints and preparations for coating.
3. 2x Coats of Belzona 5231 including recessing for new system parts.

The damaged floor was mechanically removed, cleaned and rebuilt, various areas sealed using Belzona 1111 and Belzona 1212. Followed by 2 coats of Belzona 5231. Finally, new expansion joints were formed using Belzona 4521. The application was carried out in accordance with Belzona System Leaflet FPA-01 & FPA-06
