# PUMP COATING WITH BELZONA 1341

ID: 8548

High pressure pump with 7 stages (KSB Multitec A100 / 7-8) The new pumps, which came directly from the manufacturer, are required to operate snow-making systems in a ski area.

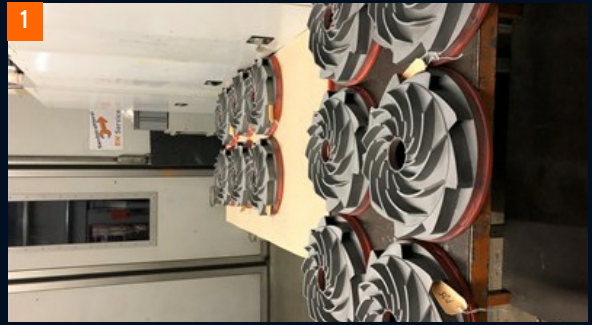
1). Sandblasted guide vanes 2). Coated impeller which is machined with CBN inserts 3). Finished guide vane in the housing 4). Pump during assembly

The pumps were delivered directly to our service center by the manufacturer. We then dismantled the pumps and measured the clearance on the impellers. The running wheels were then turned on the lathe in order to obtain the original dimensions at the end. All components of the pump were sandblasted SA.2.5 After sandblasting, the components were immediately coated with Belzona 1341 Supermetalgilde. After a curing time of 14 hours, the wheels were turned back to their original dimensions on the lathe with the help of CBN inserts. Before assembly, the impellers were checked for imbalance and balanced.
