# BELZONA SEALS AN EMERGENCY BASIN

ID: 8549

Emergency storage basin.

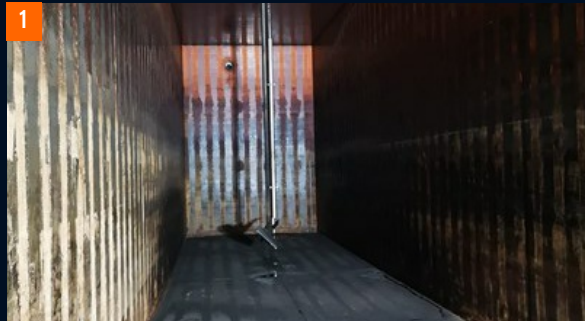
- 1). Overview of the emergency basin.
- 2). Failing butt joints through which water penetrates to the outside.
- 3). Removal of glassfiber matting via the use of grinding.
- 4). The joints were re-sealed with 2 layers of Belzona 9341 impregnated in Belzona 5811.

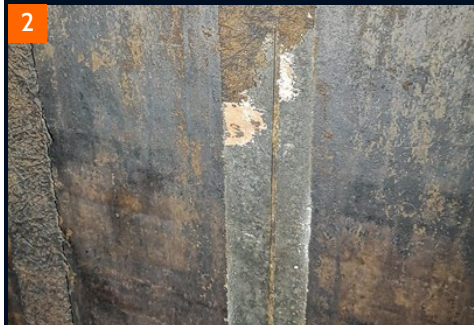
Leaks were found at the butting of joints. The old joints had been mated and sealed using glue and glass fiber mats to prevent leaks which later failed - 195 butting joints had to be repaired.
