# CARGO SHIP BOW THRUSTER REPAIRED WITH BELZONA

ID: 8553

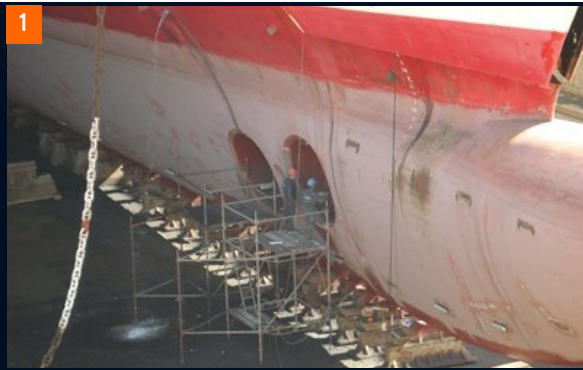
1 : Vessel out of water

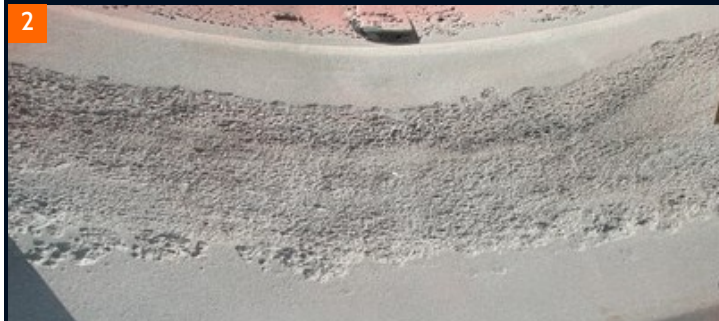
Thruster tunnel suffers from erosion/corrosion that leads to cavitation and pitting

2 : Significant pitting on upper surfaces

The repair was carried out in accordance with Belzona System Leaflet SOS 02. Damaged area was roughened to have a minimum profile depth of 3 mil and degreased with Belzona 9111. Belzona 1311 was applied to fill the pitting.

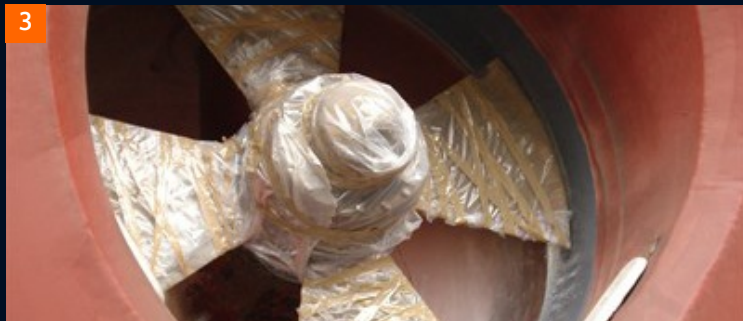
3 : Completed Application
