# BELZONA PREVENTS WEAR ON AN ASH SLURRY MIXER

ID: 8555

Cogen powerplant ash slurry mixer

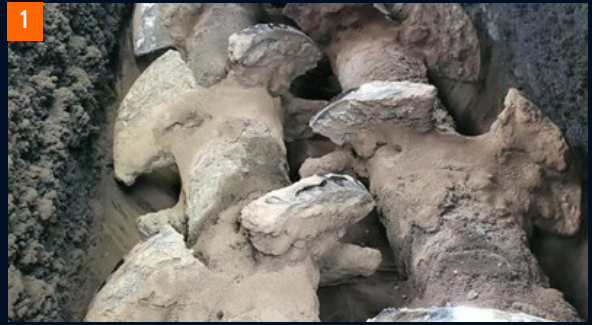
The paddles on their ash slurry mixer would wear down to less than half of their original length in 3 months forcing them to be replaced. The original paddles were made from hardox steel. The mixer box and shafts had some mild wear and corrosion as well.

1. Original condition
2. Box coated with Belzona 1331
3. Shafts coated with Belzona 1331
4. Paddles being coated with Belzona 1813
