# HEAT EXCHANGER REPAIR & COATING WITH BELZONA

ID: 8558

A heat exchanger had suffered damage from erosion & corrosion in service.

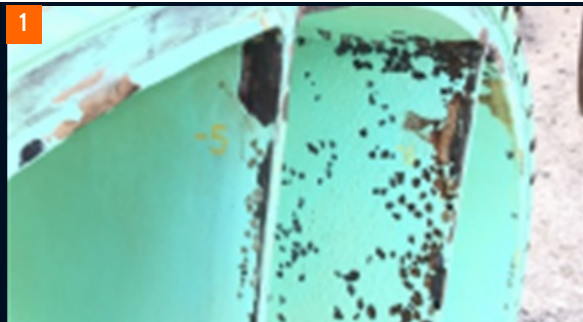
1 - Damage to the coating & underlying metal

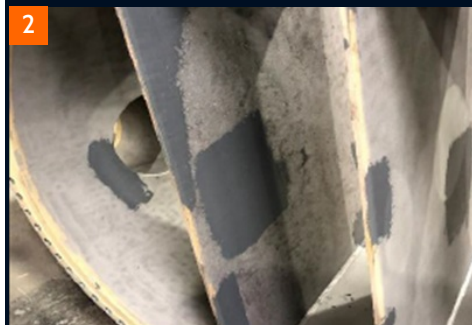
2 - Surface preparation & rebuilding with Belzona 1311

The existing coating was removed during the grit blast preparation. The metal was prepared to SA2.5 & 75 microns. Any areas of metal loss were repaired using Belzona 1311 Ceramic R metal. Two coats of Belzona 1321 Ceramic S Metal were then applied for future erosion/corrosion protection.

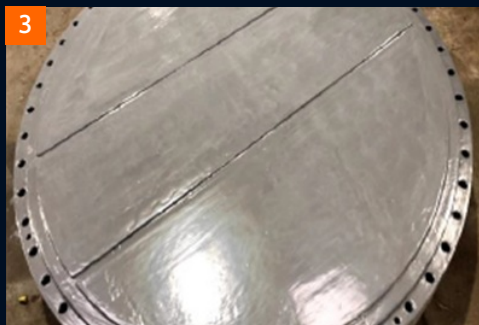
3 - End cover coated with Belzona 1321

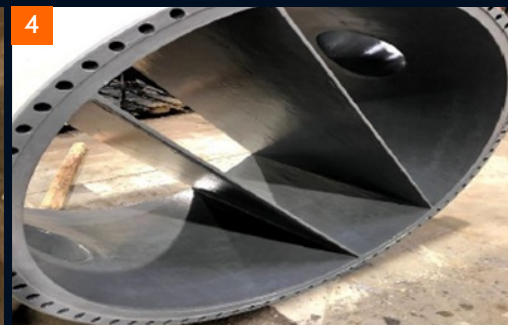
4 - Belzona 1321 applied
