# BUSH HOUSING BONDED IN PLACE WITH BELZONA

ID: 8559

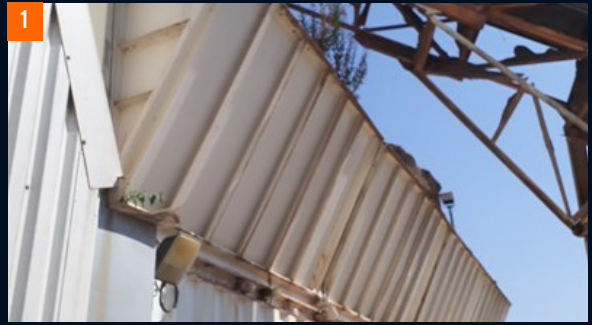
- 1 - Conveyor system
- 2 - Surface preparation on the housing
- 3 - Bushing to be bonded in place
- 4 - Belzona 1111 Supermetal applied & bushing bonded

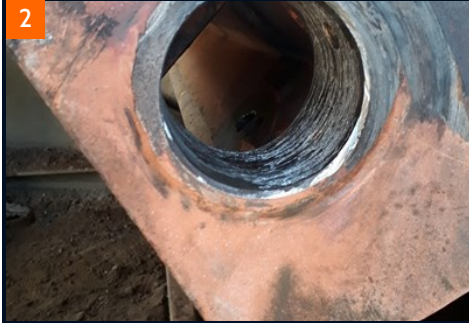
A bush housing had become oversize due to wear & corrosion. The bush was spinning whilst the machinery was in operation, this was causing further wear.

The housing & bush were prepared using an angle grinder. Belzona 1111 (Supermetal) was then applied to both parts. The bush was then inserted & aligned.
