# REPAIR OF DRINKING WATER TANK WITH BELZONA 5811DW2

ID: 8560

Renovation of a Water tank on site using a Belzona Drinking Water approved coating.

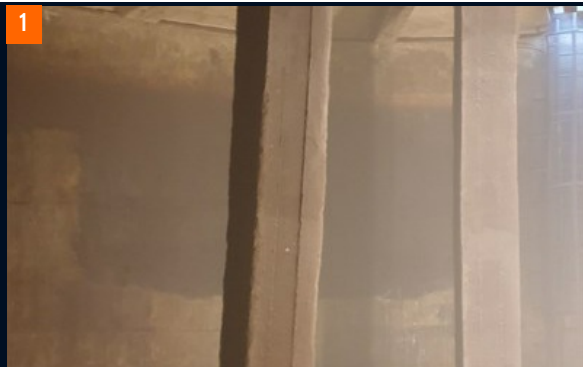
The concrete walls of the water tank had corroded over time leading to deterioration of the substrate subsequently leading to a poorer quality water quality.

Image 1: Inside of the Water Tank

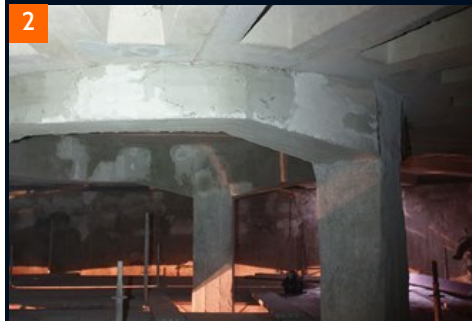
Image 2: Re-Build of the Concrete using Belzona 4111

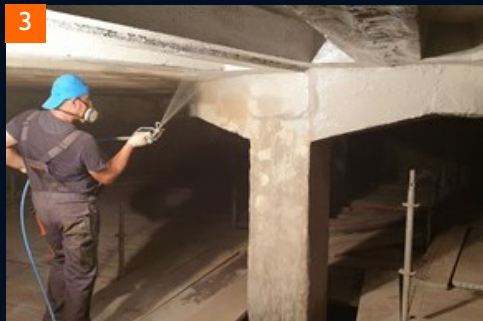
Image 3: Spraying Belzona 5811DW2

Belzona 5811DW2 is a WRAS approved coating for Potable Water, spray applied allowing for a quick and easy return to service.

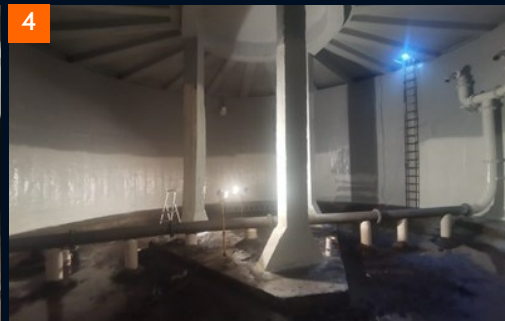
Image 4: Completed Application
