# BELZONA STRENGTHENS NOZZLES OF CLOSED DRAIN DRUM ON OFFSHORE PLATFORM

ID: 8569

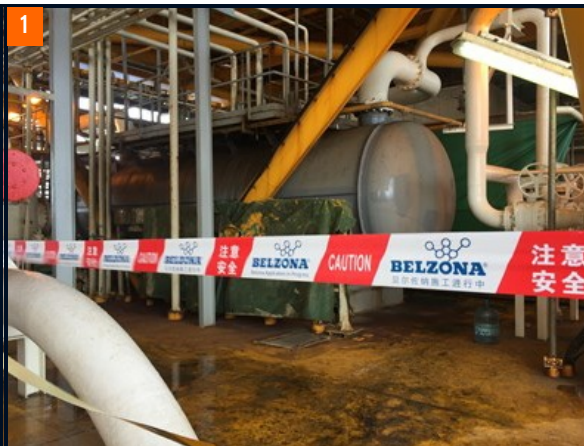
The nozzles of closed drain drum had developed thin-wall defect due to CUI.

1. Surface preparation with water blasting
2. Condition of Nozzles after sandblasting
3. Complete application of Belzona Superwrap II
4. View of nozzles after 3 years

The repairs were designed in accordance with ISO24817 standard. The application was completed by Belzona trained and validated installers in accordance with Belzona Know-How System Leaflet VPF-11. Belzona supervisor and the on-site representative supervised the whole process. The whole application involved 2 one and half-inch nozzles, 14 two-inch nozzles, 1 three-inch nozzle and 4 four-inch nozzles.

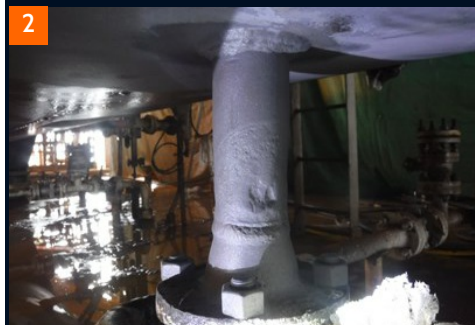
Nozzles of closed drain drum on offshore platform suffering from corrosion and significant thickness loss. The design pressure is 0.35MPa, the design temperature is -19°C~110°C.

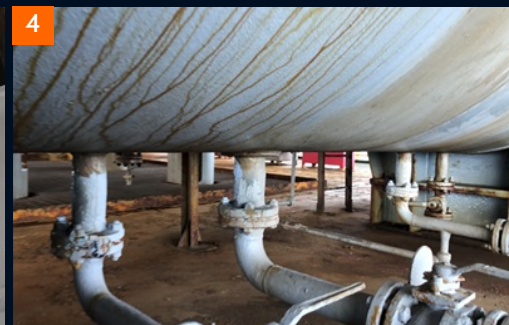
For conventional welding, the whole closed drain drum need to be shut down and isolated, with thorough cleaning and water injection, which costs at least 15 days of downtime and affects the production. Welding in confined space may also cause hazards. Therefore, the customer has been looking for the solutions with no hot work required but also accepted by classification society. Meeting the standard of ISO24817 and ASME PCC-2, Belzona Superwrap II can repair the nozzles of pressure vessels on-site, with no downtime or hot work required. The application is still in good condition after 3 years.
