# BELZONA STRENGTHENS NOZZLES OF HIGH-PRESSURE FLARE SCRUBBER ON OFFSHORE PLATFORM

ID: 8570

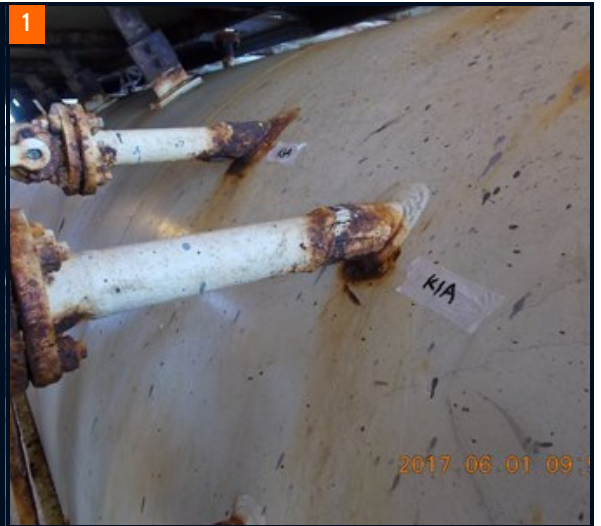
Due to the damage of the original insulation layer, the nozzle of the high-pressure flare scrubber was corroded under the insulation layer (CUI). The thickness of the nozzle was seriously reduced.

1. Nozzles with serious corrosion problems
2. Surface preparation with water blasting
3. Complete application of Belzona Superwrap II
