# BELZONA REPAIRS NOZZLES WITH THROUGH-WALL DEFECT ONLINE ON OFFSHORE PLATFORM

ID: 8571

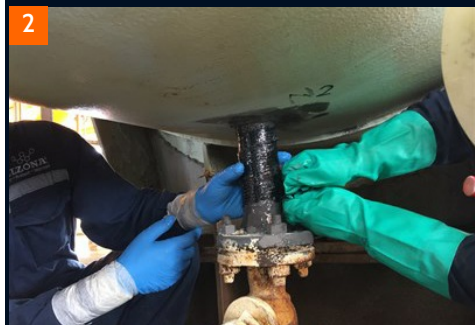
The nozzles of closed drain drum had developed thin-wall defect and through-wall defect due to CUI.

1. Nozzle with through-wall defect
2. During Belzona Superwrap II application
3. Complete application of Belzona Superwrap II application
4. View of nozzles after 3 years

The repairs were designed in accordance with ISO24817 standard. The application was completed by Belzona trained and validated installers in accordance with Belzona Know-How System Leaflet VPF-11. Belzona supervisor and the on-site representative of BV supervised the whole process. The whole application involved 2 one and half-inch nozzles, 15 two-inch nozzles, 1 three-inch nozzle and 4 four-inch nozzles. One of the 2" nozzles has developed through-wall defect.
