# BELZONA RESTORES NOZZLES OF CLOSED DRAIN DRUM ONLINE ON OFFSHORE PLATFORM

ID: 8572

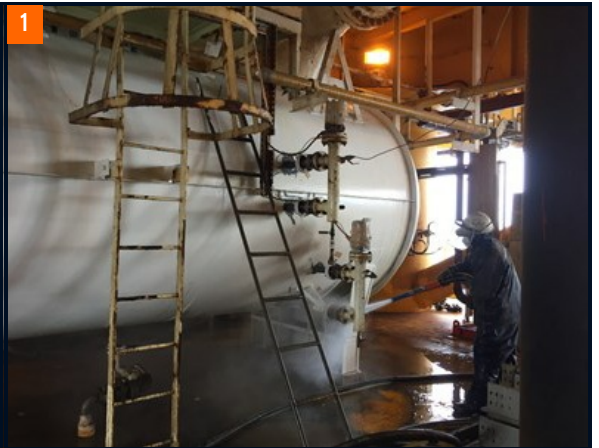
The nozzles of closed drain tank had developed thin-wall defect due to CUI.

1. Nozzles during gritblasting
2. Condition of Nozzles after gritblasting
3. Complete application of Belzona Superwrap II
4. View of nozzles after 3 years

The repairs were designed in accordance with ISO24817 standard. The application was completed by Belzona trained and validated installers in accordance with Belzona Know-How System Leaflet VPF-11. Belzona supervisor and the on-site representative supervised the whole process. The whole application involved 2 one and half-inch nozzles, 12 two-inch nozzles and 1 four-inch nozzle.

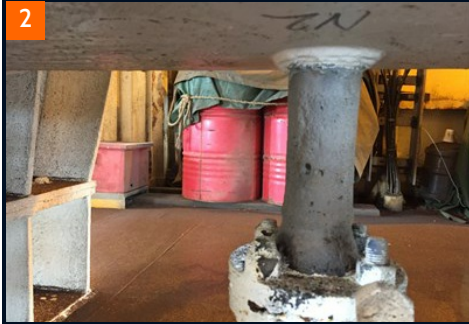
Nozzles of closed drain drum on offshore platform suffering from corrosion and significant thickness loss. The design pressure is 1.035MPa, the design temperature is -46°C~110°C.

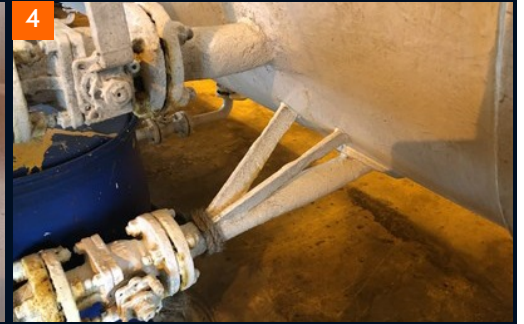
For conventional welding, the whole closed drain tank need to be shut down and isolated, with thorough cleaning and water injection, which costs at least 15 days of downtime and affects the production. Welding in confined space may also cause hazards. Therefore, the customer has been looking for the solutions with no hot work required but also accepted by classification society. Meeting the standard of ISO24817 and ASME PCC-2, Belzona Superwrap II can repair the nozzles of pressure vessels on-site, with no downtime or hot work required. The application is still in good condition after 3 years.
