# BELZONA SUPERWRAP II EXTENDS LIFE OF PIPING BY 10 YEARS

ID: 8574

High Pressure, Fuel Oil Piping

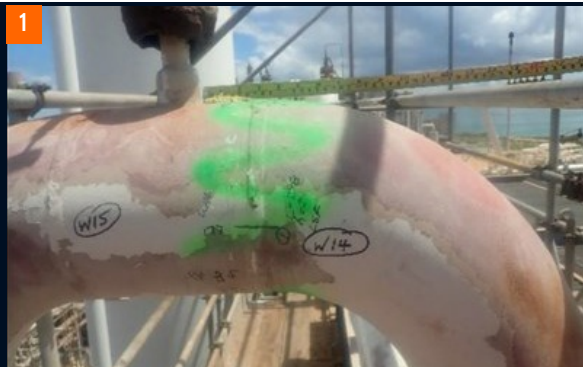
The 250 mm diameter pipe had developed a critical (Class 3) through wall defect at the bent. The operating temperature was 50°C and the operating pressure was 15 bar.

1. Defect area of the pipe
2. Surface abrasive blasted
3. Application in progress
4. Release Film over the wrap waiting to cure

The application was completed in accordance with Belzona Know-How System Leaflet VPF-11. The defect area was abrasive blasted to SA 2.5 with a 75 microns profile. Belzona SuperWrap II was applied in accordance with the engineered design as an 8 wrap system with the total length of 490 mm, using Belzona 1983 resin to provide a further 12 years service life.
