# BELZONA SUPERWRAP II EXTENDS LIFE OF A HIGH TEMPERATURE PIPELINE BY 5 YEARS

ID: 8575

High Temperature, Fuel Oil Pipeline

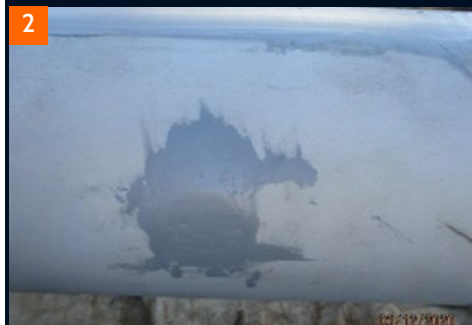
The 406 mm diameter pipe had developed a critical (Class 3) through wall defect calculated at 40 x 40 mm. The operating temperature was 90°C and the operating pressure was 17.6 bar. The total defect length was 90 mm in axial.

1. Defect in the pipe
2. Defect pit filled with Belzona 1511
3. Application in progress
4. Application completed
