# BELZONA SUPERWRAP II RETURNS PIPING BACK TO SERVICE IN 48 HOURS

ID: 8577

High Temperature, Hydrocarbon Piping

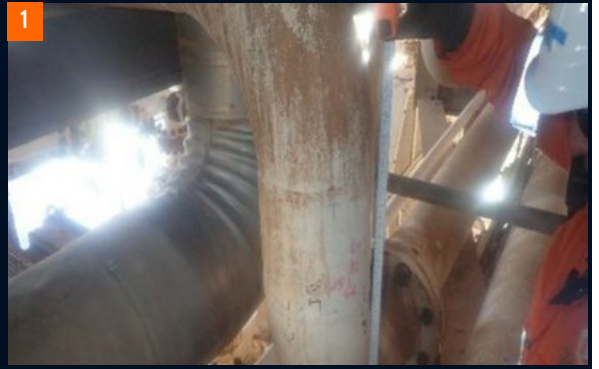
The 220mm diameter pipe had developed a critical (Class 3) thin wall defect at the bend. The operating temperature was 95°C and the operating pressure was 10 bar. The total defect length was 280mm in axial.

1. Measuring the corroded pipe
2. Wetting out the Reinforcement Sheet
3. Wrapping the pipe
4. Applying the Release Film over the wrap

The application was completed in accordance with Belzona Know-How System Leaflet VPF-11. The defect area was abrasive blasted to SA 2.5 with a 75 microns profile. Belzona SuperWrap II was applied in accordance with the engineered design as a 6 wrap system, using Belzona 1983 resin to provide a further 12 years service life.
