# BELZONA REBUILDS 1.5M DIAMETER CONDENSER FLANGE FACE

Exhaust Condenser Flange Rebuild.

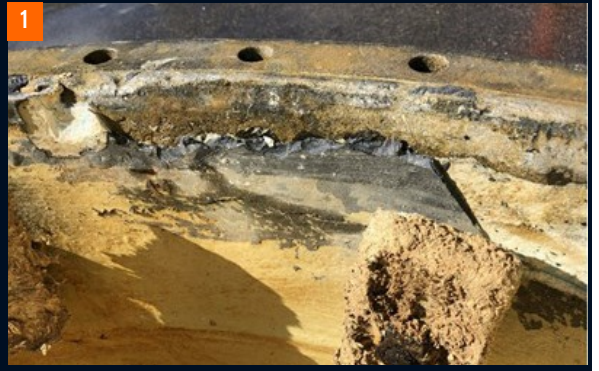
The previous repair on the Condenser Flange had failed and the customer was fearing that it would start leaking. This would cause unplanned downtime costing thousands of dollars.

1. Close up of the damaged flange.
2. 1.5m diameter Flange Former.
3. Flange Former bolted in place.
4. Completed application.

The application was carried out in accordance with Belzona System Leaflet VPF 13 by using a 1.5m diameter, 50mm thick, flat Flange Former coated with Belzona 9411 and left to dry. Belzona 1121 was applied to the flange face and using a plastic applicator with a "V" cut out, was shaped all around with a 6mm high peak in the center. 2mm spacers were placed evenly all round to ensure the Former would sit level when bolted down. 1mm thick Belzona 1121 was then applied to the Former before bringing the two together and bolting up the former. The Belzona 1121 was left overnight to cure before gently removing the Former.
