# OFFSHORE HEAT EXCHANGER MAINTENANCE WITH BELZONA.

ID: 8580

Severe bimetallic corrosion to offshore heat exchanger endplates.

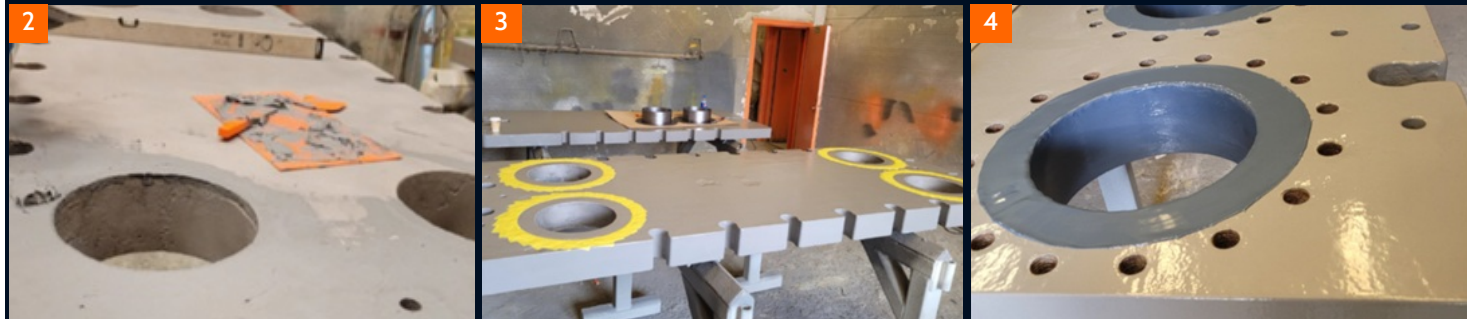
Existing titanium bushings had caused severe bimetallic corrosion on the carbon steel endplate surfaces. The titanium bushing endplate surfaces was in urgent need of rebuilding and protective coating. Design Temperature 90 °C.

1. Corroded area
2. Corroded areas rebuilt using Belzona 1511
3. Endplates coated with Belzona 1391S (Spray applied 2 coats a 375µm) and prepared for forming new bushings with Belzona 1391 Ceramic HT using metal formers.
4. Complete application

The application was carried out in accordance with Belzona System Leaflet HEX-03. Following removal of existing titanium bushings the endplates was gritblasted to SA 2,5 and 75µm surface profile. All corroded area was rebuildt in stages using Belzona 1511 Super HT Metal. Belzona 1391S was spray applied in 2 coats a 375µm. New bushings was applied/installed with Belzona 1391 Ceramic HT using custom made formers
